Groundsource Drilling for Social Housing Project

Ground Source Heat Borehole Drilling in Cornwall

**Groundsource Boreholes
completed for local company.**

Sea Wall Repair Completed in St Mawes

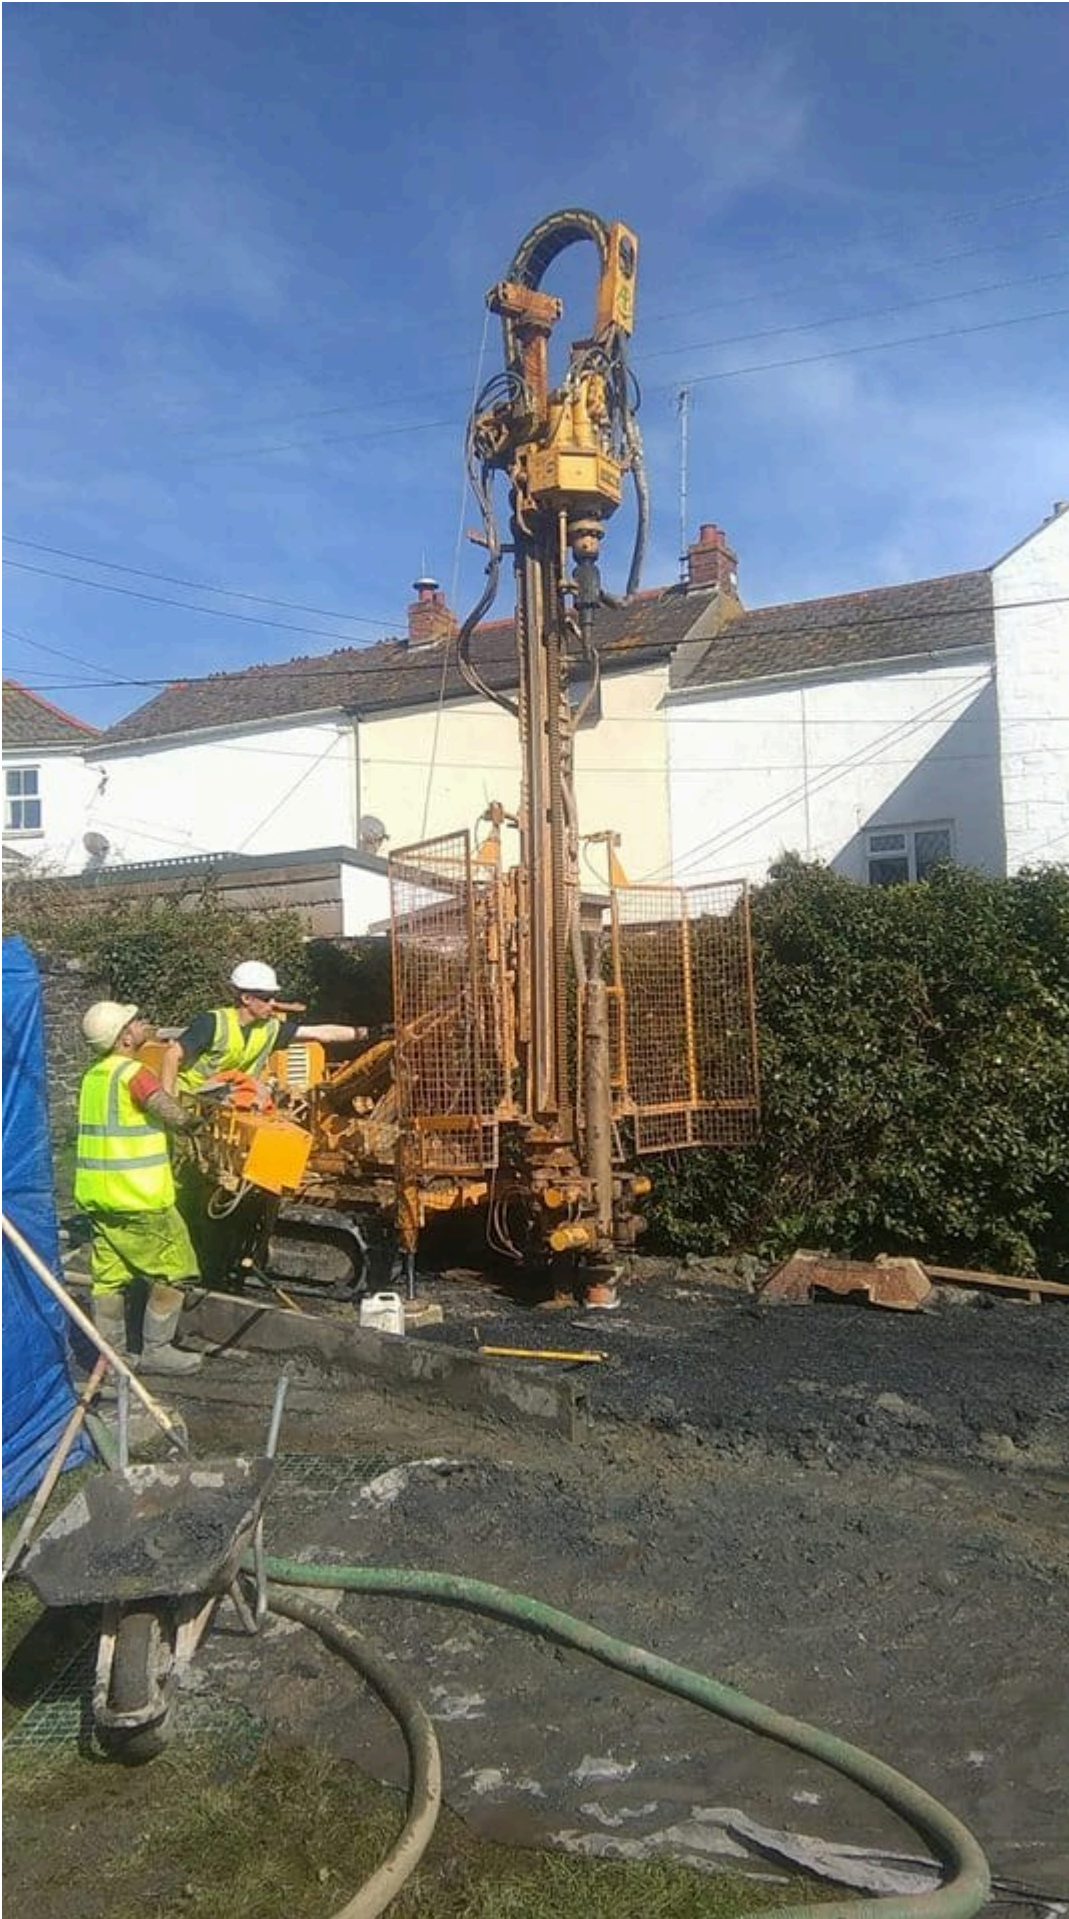
Drilling Ground Source Heat Pump Boreholes

Aquasource (SW) Ltd t/a Groundsource SW have started work on a 12 hole Ground Source Heat Pump drilling project for a local Ground Source Heat Pump installer in South West Cornwall.

The Ground Source holes are being drilled to a maximum depth of 103m and on completion will be fitted with Geothermal probes and backfilled using special thermally conductive grout.

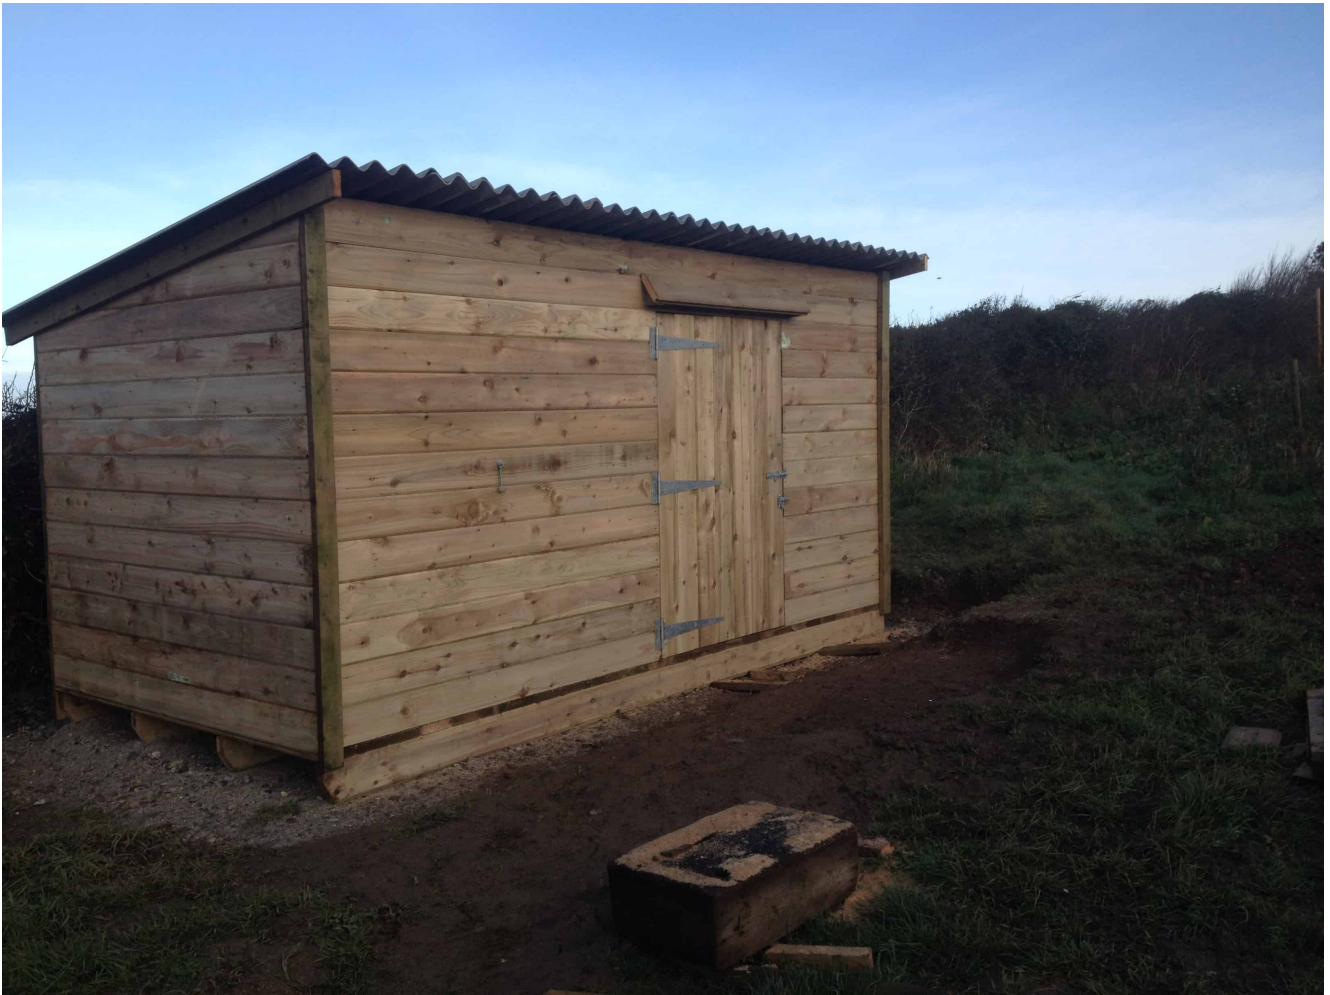
Bespoke Shed Built for Customer

A customer came to us with a requirement for water filtration but was worried that a commercially supplied shed would not be strong enough in his very exposed location.

Graham and Preston built a bespoke heavy duty shed that was up to anything the weather could throw at it.

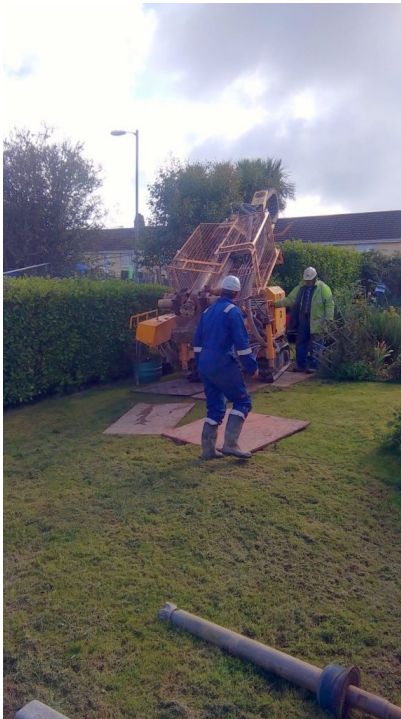
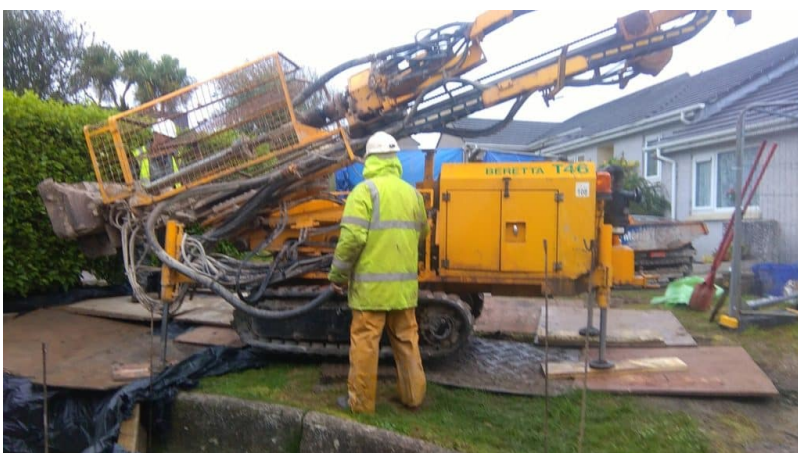
Aquasource (SW) Ltd t/a Ground Source South West has started a Ground Source Heat Pump project on the Lizard Peninsular.

The project involves drilling up to 120m deep boreholes in the very small front gardens of social properties on an estate.

The access is very tight and we were just able to squeeze our Beretta T46 into the space available.

The ground is a very hard granite type rock with clay bands.

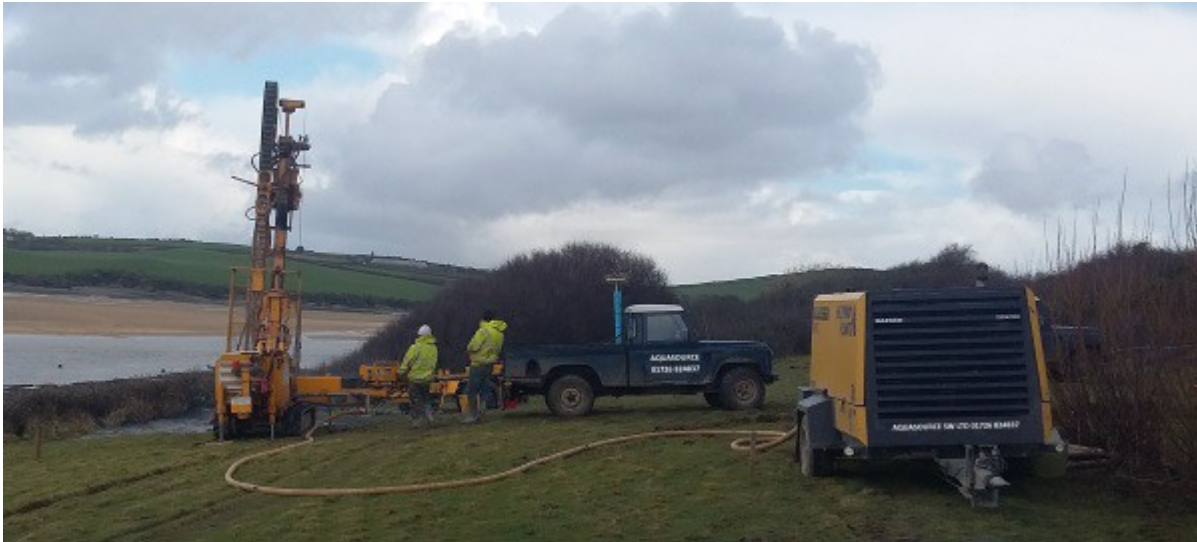
hole Drilling

Aquasource (SW) Ltd have successfully completed 1280m of groundsource heat pump boreholes on one site for a local company at a project near Wadebridge in Cornwall.

The 'down the hole hammer' drilling technique was used to drill the holes.

The borehole comprise 10 number, 127mm diameter holes drilled to a depth of 120m.

Because a design life of 25+ years was required crack resistant polyethylene Geothermal probes were inserted into the holes.

To ensure maximum performance the boreholes were backfilled with thermally conductive material.

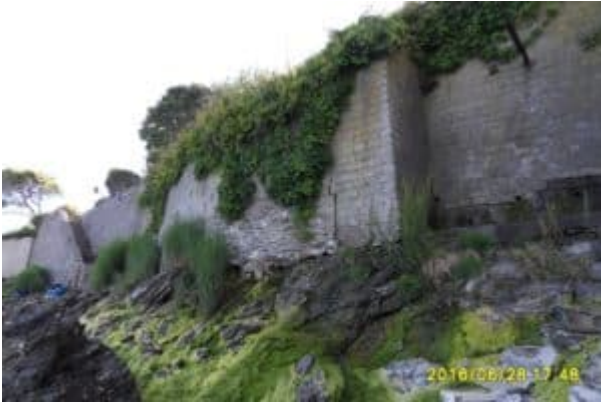
Before :- Sea Wall damaged by storms

The Sea Wall had been damaged in the storms of February 2013 and our client had engaged [Richard Holbrook](#) as a structural engineer to design a cost effective solution.

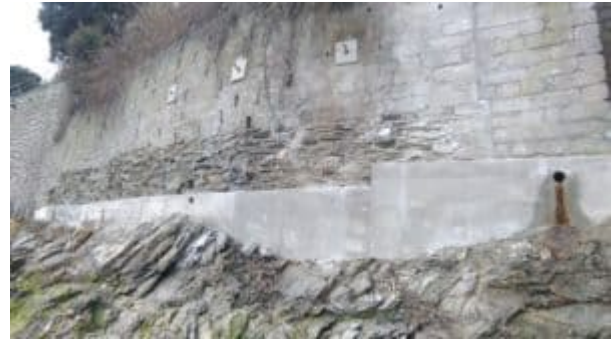
View of Sea Wall Repair

The sea wall repair comprised the construction of a new wall along the base of the existing wall, the installation of self

drilling rock anchors and crack stitching to the existing wall.
